Final Report

Pilot quantification of the effects of wave action on eastern oyster reefs in the Matanzas River portion of the Northern Coastal Basin of Florida.

Prepared By:
John Hamilton
Estuarine Biogeochemistry Laboratory
Whitney Laboratory for Marine Bioscience
University of Florida

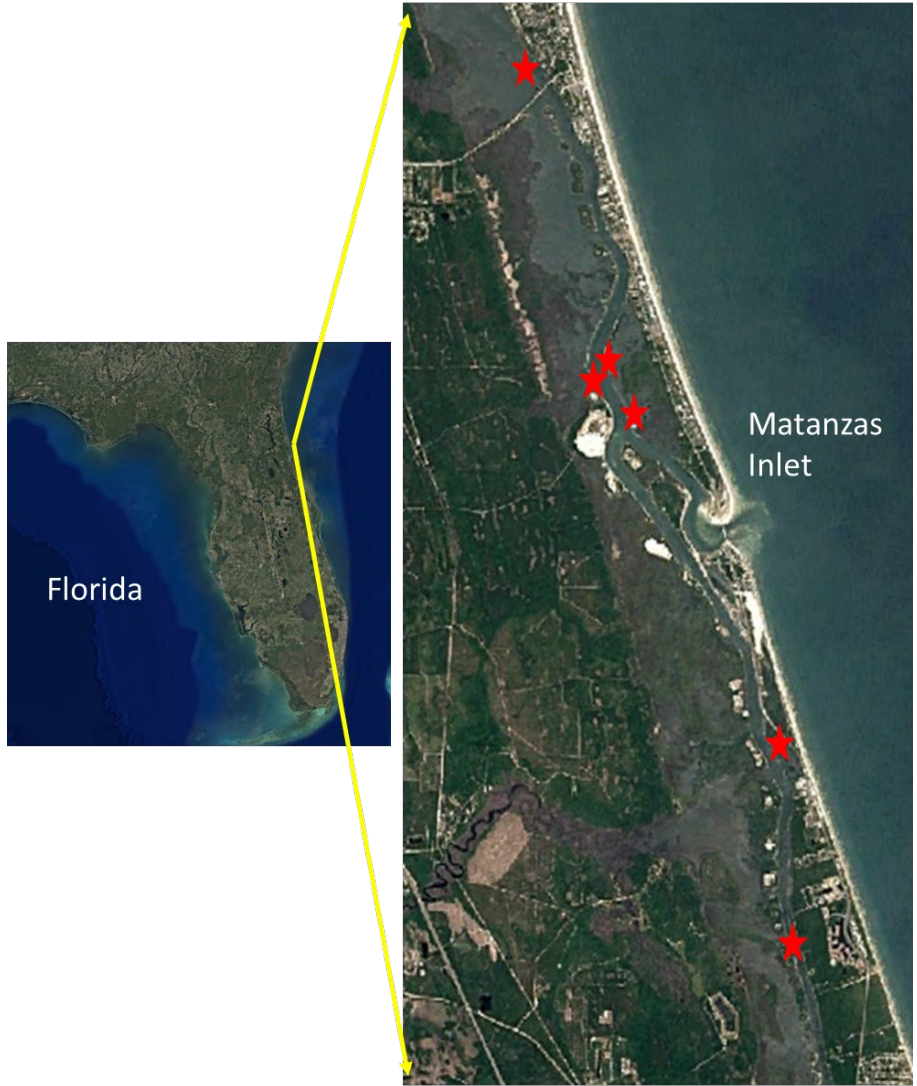
Figure 1. Study reef pairs (red stars) located in southern St. Johns and northern Flagler counties on the Matanzas River. Each site represents a wave exposed and a wave protected reef.

Six reef pairs (12 total reefs) were identified in southern St. Johns County and northern Flagler County on the Matanzas River (Figure 1, Table 1). At each site (Figures 2A-F), a reef exposed to direct wave energy from boat traffic and wind driven waves was paired with a nearby reef protected from wave energy. In all cases the distance between the exposed reef and the protected reef was less than 100m.

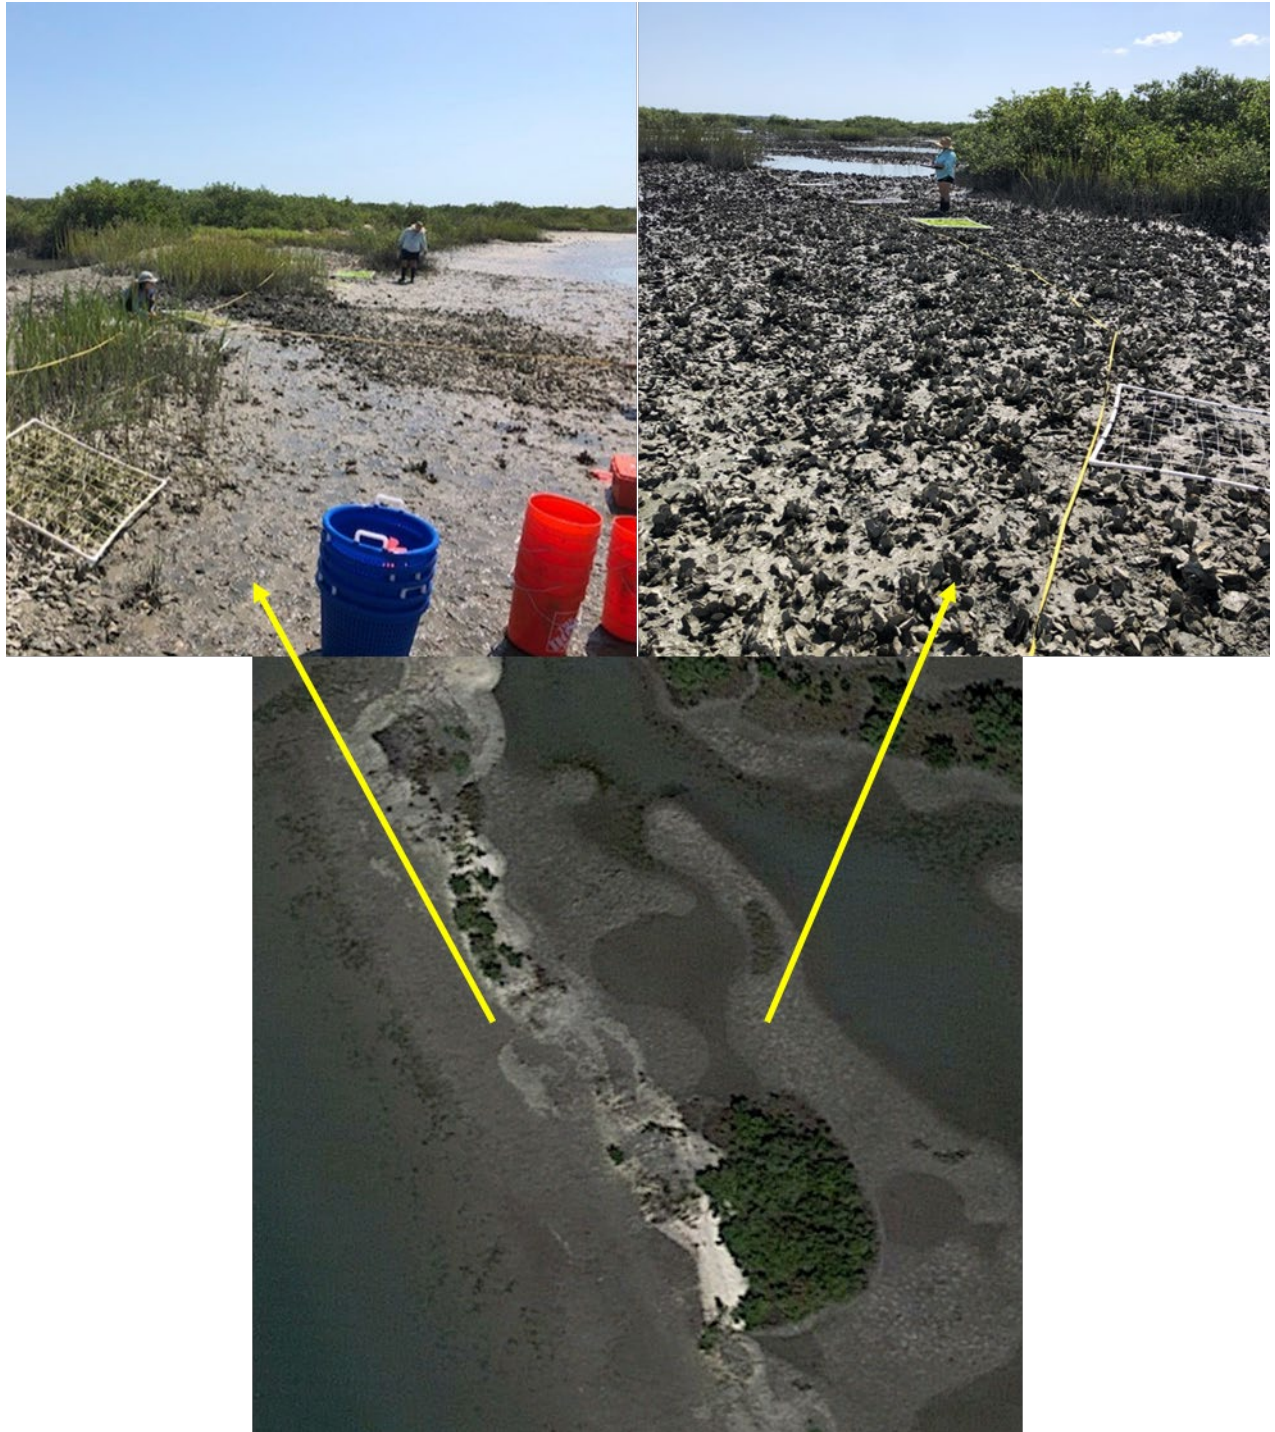
Figure 2B. Reef pair 2 (Matanzas Inlet East) located just north of the Matanzas Inlet on the east side of the Matanzas River. Wash over induced transport of sediments and scouring of shell material by waves is clearly indicated on the wave exposed reef (left).

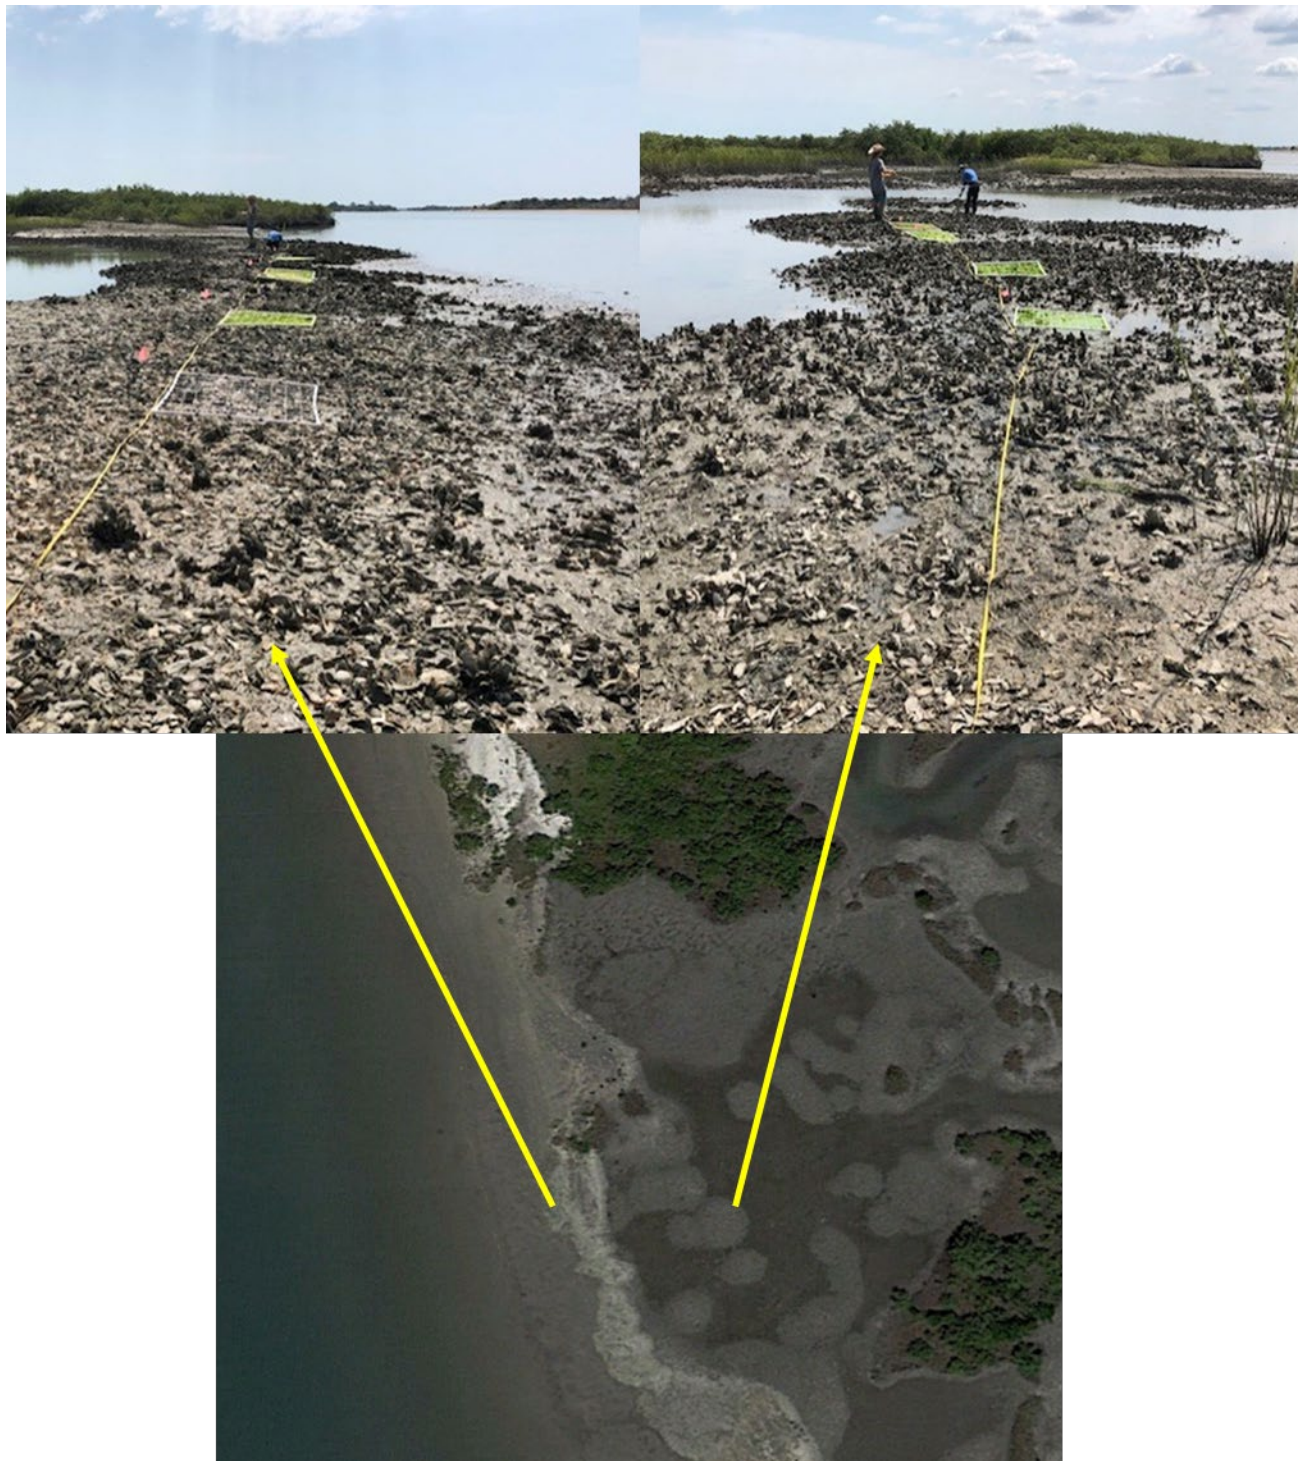
Figure 2C. Reef pair 3 (Matanzas Inlet East 2) located just north of the Matanzas Inlet on the east side of the Matanzas River. Wash over induced transport of sediments and scouring of shell material by waves is indicated on the wave exposed reef but to a lesser extent than observed previously (left).

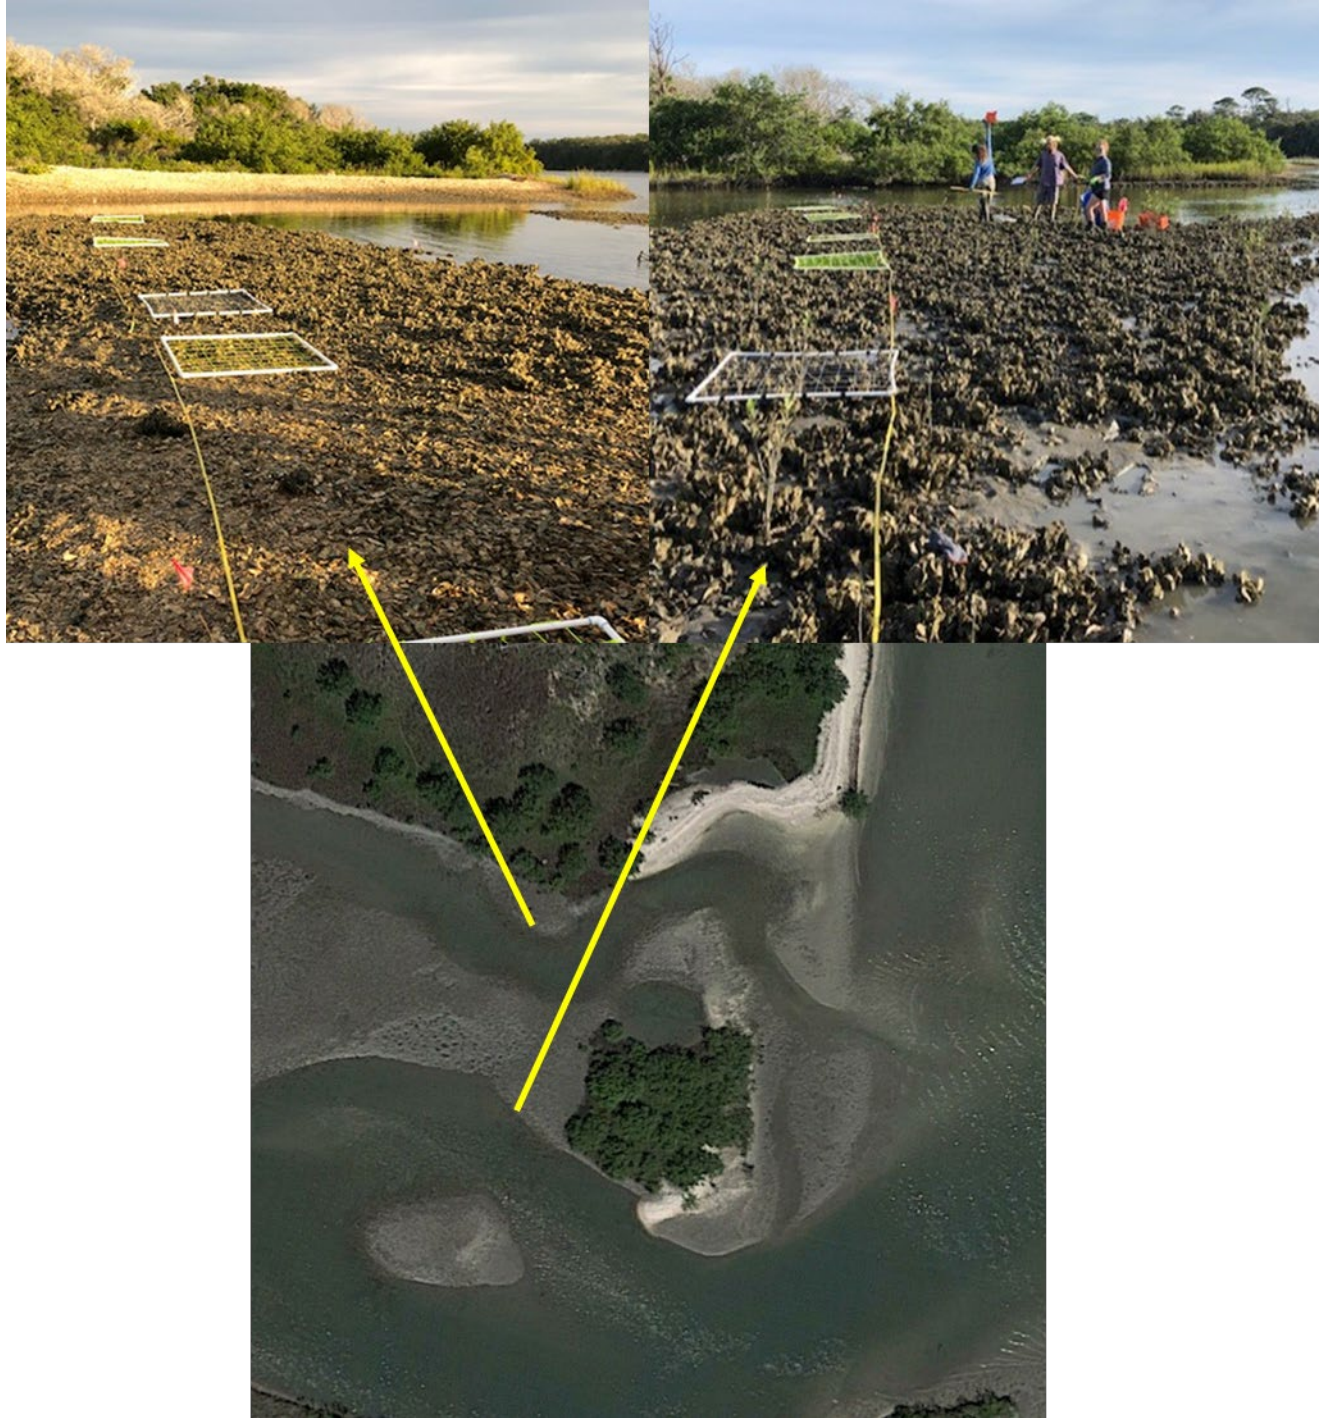
Figure 2D. Reef pair 4 (Whitney Lab South) located south of Marineland on the west side of the Matanzas River. Wash over induced transport of sediments and scouring of shell material by indirect waves is moderately indicated on the wave exposed reef (right).

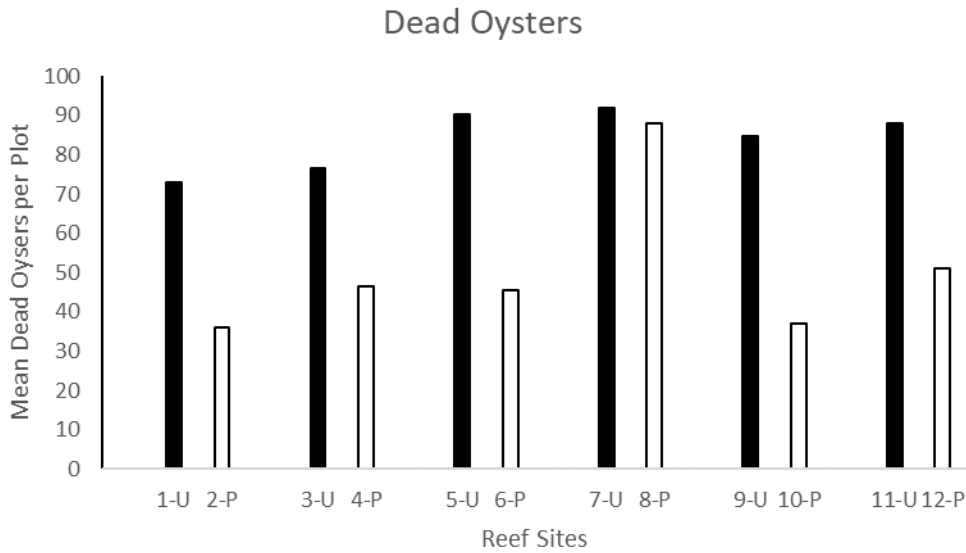
Dead oyster count (Figure 4) was also observed for protected and unprotected oyster reefs. Dead oyster count on protected reefs ranged from 36 to 88, while dead oysters on unprotected reefs ranged from 73 to 92.

Figure 4. Total dead oysters for each reef site.
