**Using Lichens as Indicators of Hydrology in Mixed Pond-Cypress
(*Taxodium ascendens*) - Pine (*Pinus* sp.) Wetlands in Central Florida**

Major Paper

Tim M. Hull

Soil and Water Science Department

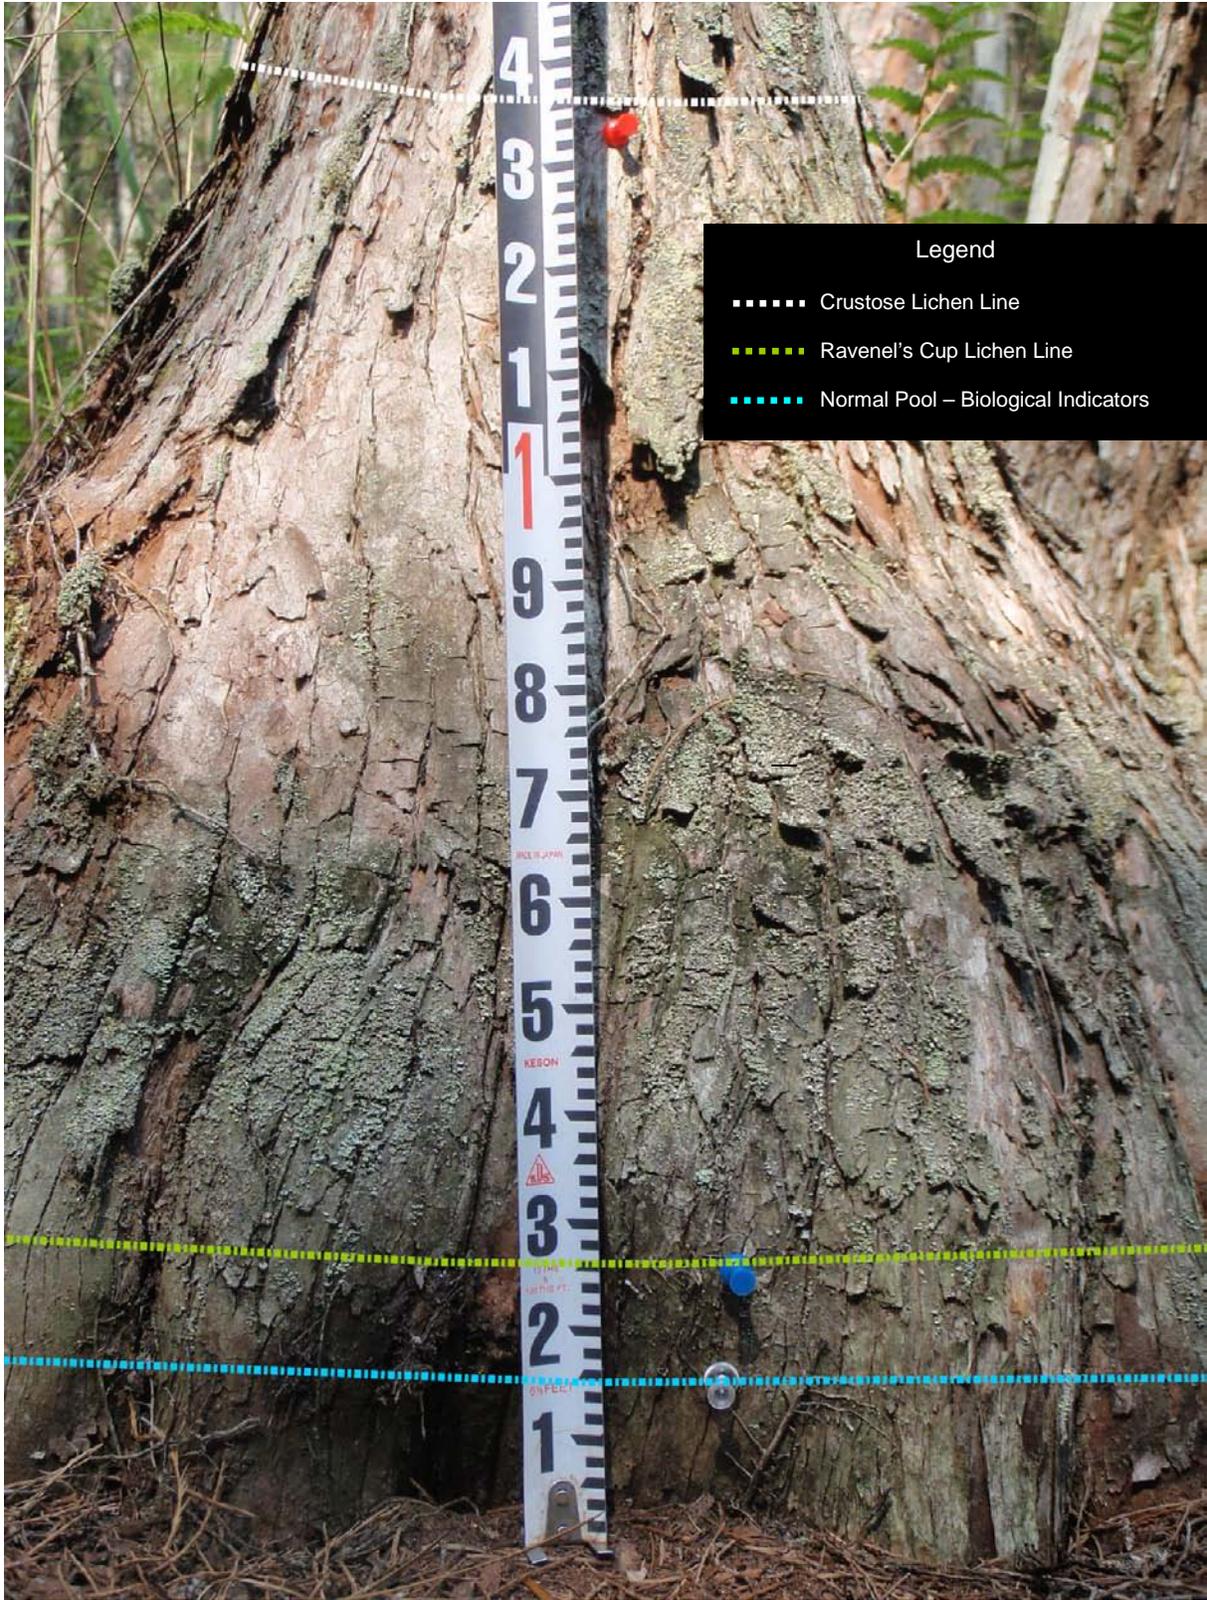
Wetland 1. Tree 2. Photo 1 of 2.

**Select Photographs of Representative Trees
And Hydrologic Indicators Selected for Study**

Tree No. 2 was located 76.10 feet east-southeast of WLR 2.1. The approximate height and DBH of Tree No. 2 was 30.00 feet and 0.34 foot, respectively, and the tree was moderately shaded. The lichens selected for study were on the west side of the tree. The soil was dry at Tree No. 2. The normal pool elevation at this tree was estimated at 1.59 feet and the indicators were the absence of lichen colonies, buttress inflection point, and rippled bark. The Ravenel's cup lichen line was at 1.70 feet. The crustose lichen line was at 2.80 feet. Other lichens noted on this tree include *Pseudoparmelia uleana* (Müll. Arg.) Elix, *Usnea mutabilis* Stirton, and an unidentified crustose lichen.
